# Chapter 2 PERIYAR RIVER BASIN

#### ENVIRONMENTAL MONITORING PROGRAMME ON WATER QUALITY

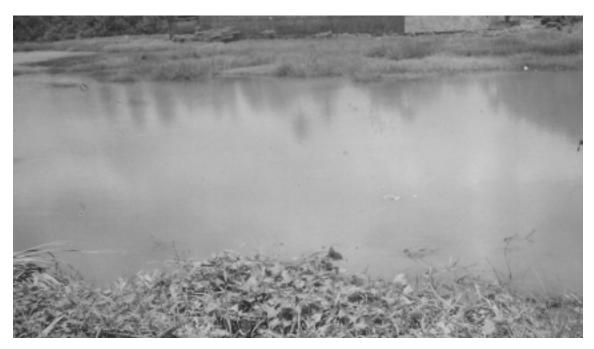
Plate 2.5: Reddish water in the vicinity of Eloor- Edayar region of Periyar river

The samples were found to be contaminated with iron, turbidity and colour. Oxidation of dissolved iron particles in water might have changed soluble iron in to red brown solid particles of ferric hydroxide, which might be the reason for the red coloration. The source of iron can be from the effluents discharged by the industries. Some of the industries located near Periyar river are listed below:
